NO5K's DME 3Watt, 10 GHZ Xverter build & minor modifications

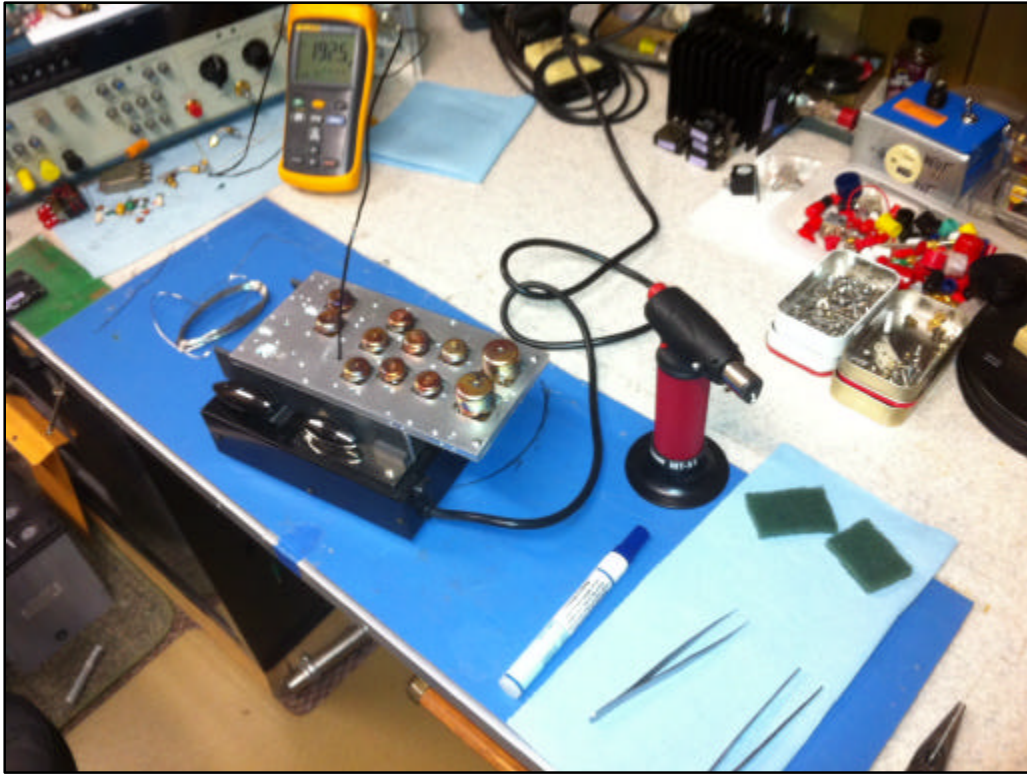
Preheating aluminum substrate and PCB to 190F facilitates quickly soldering pipe caps.

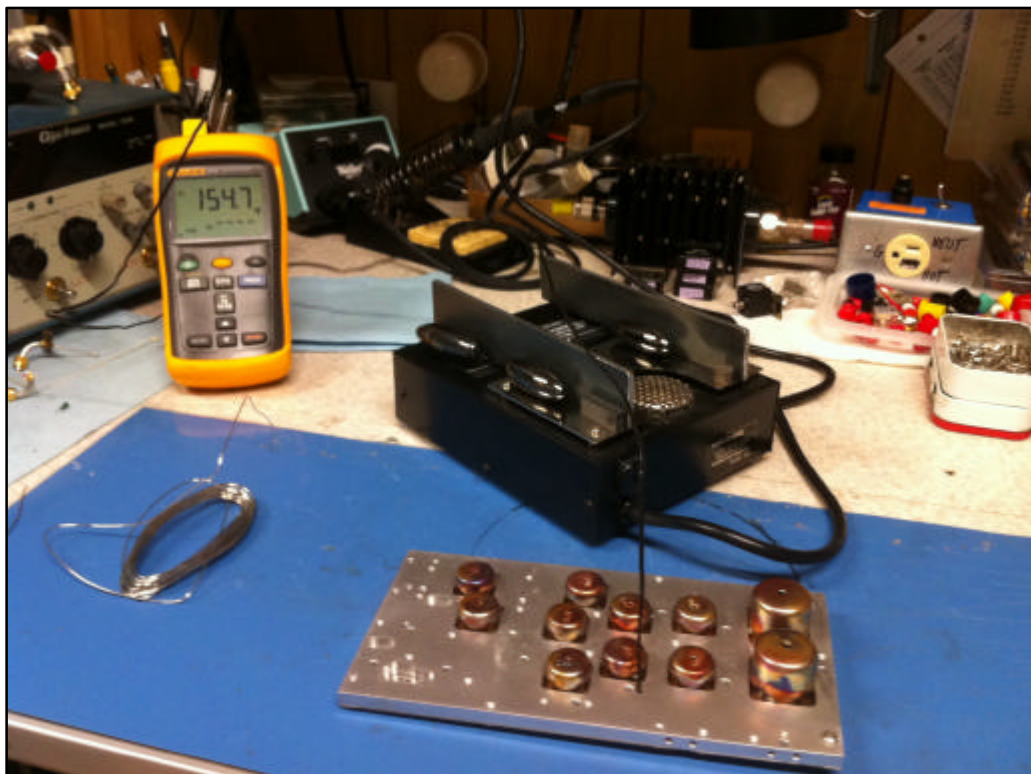
Cooling down after about two minutes of work.

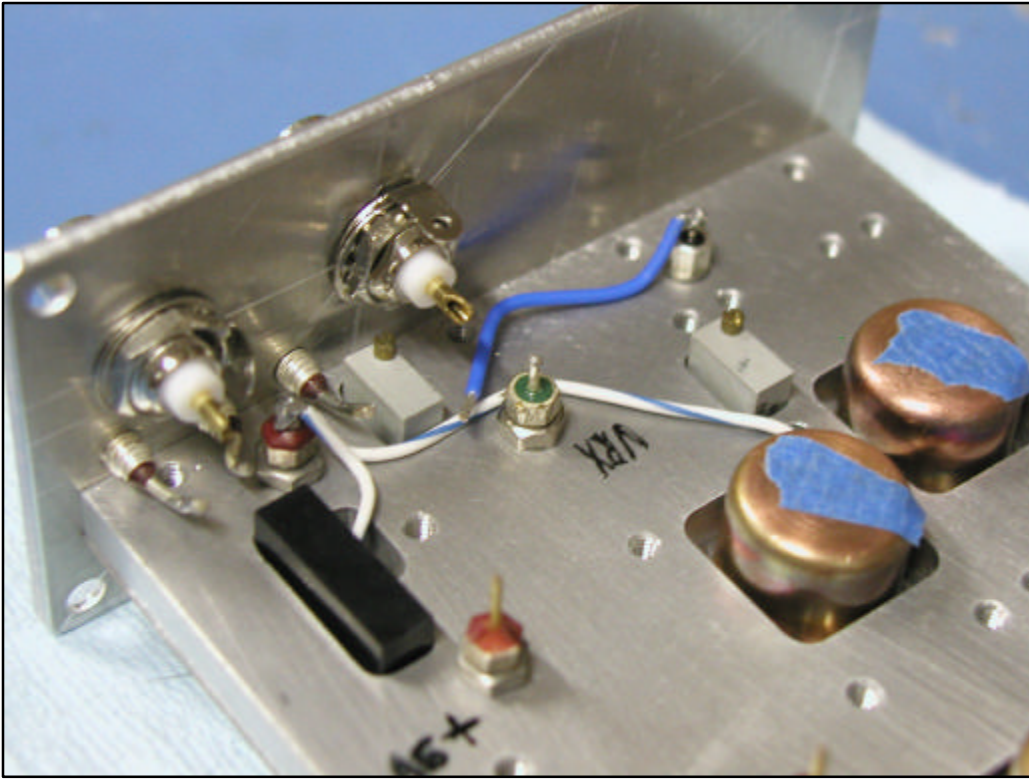
Holes from PCB to substrate tapped and feed-thru capacitors installed.

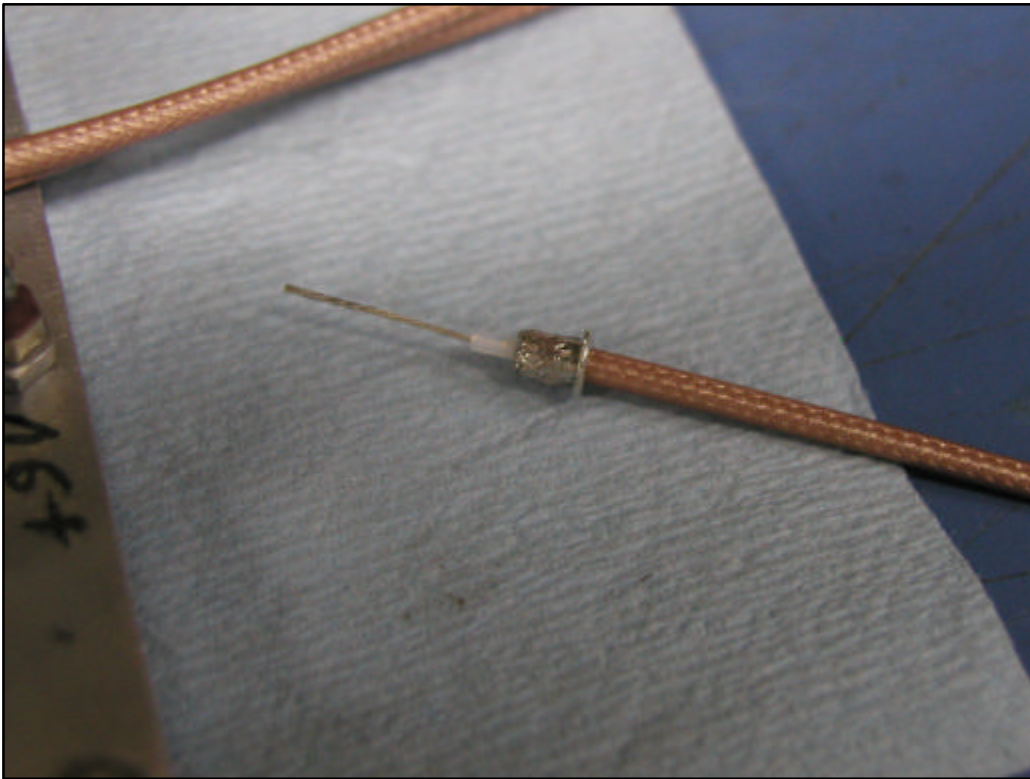
Coax prepared and soldered to rivet. (Control the OD)

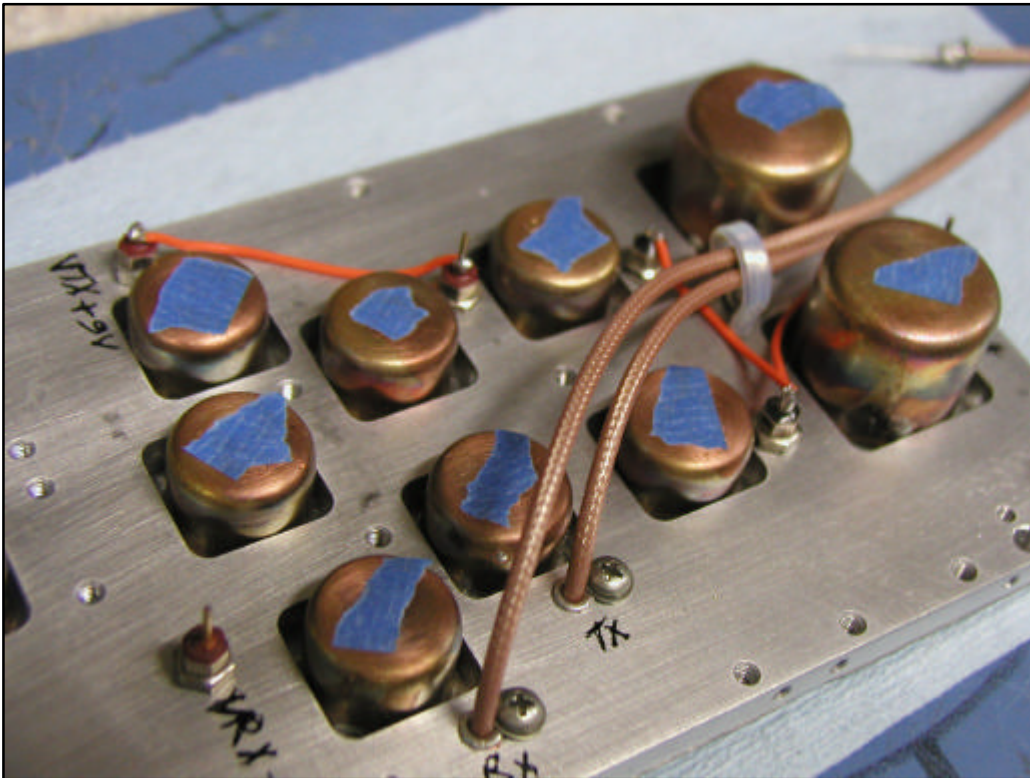
Satisfactory long-term conductivity and serviceability.

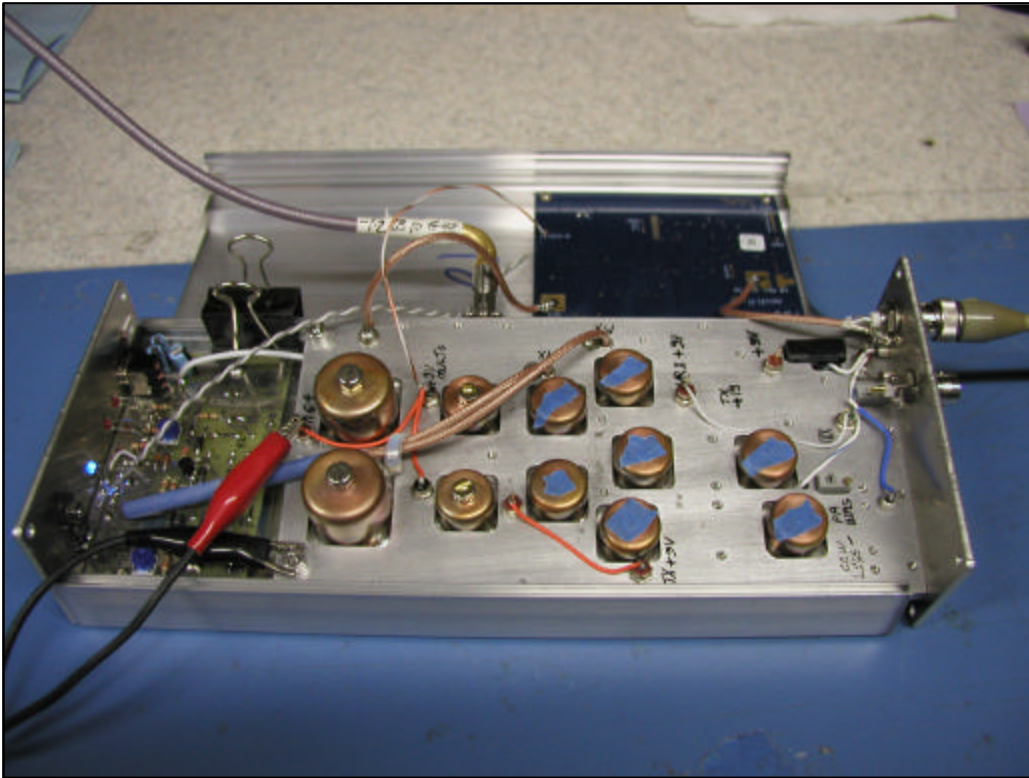
Testing LO and Mixer with lab GPS.

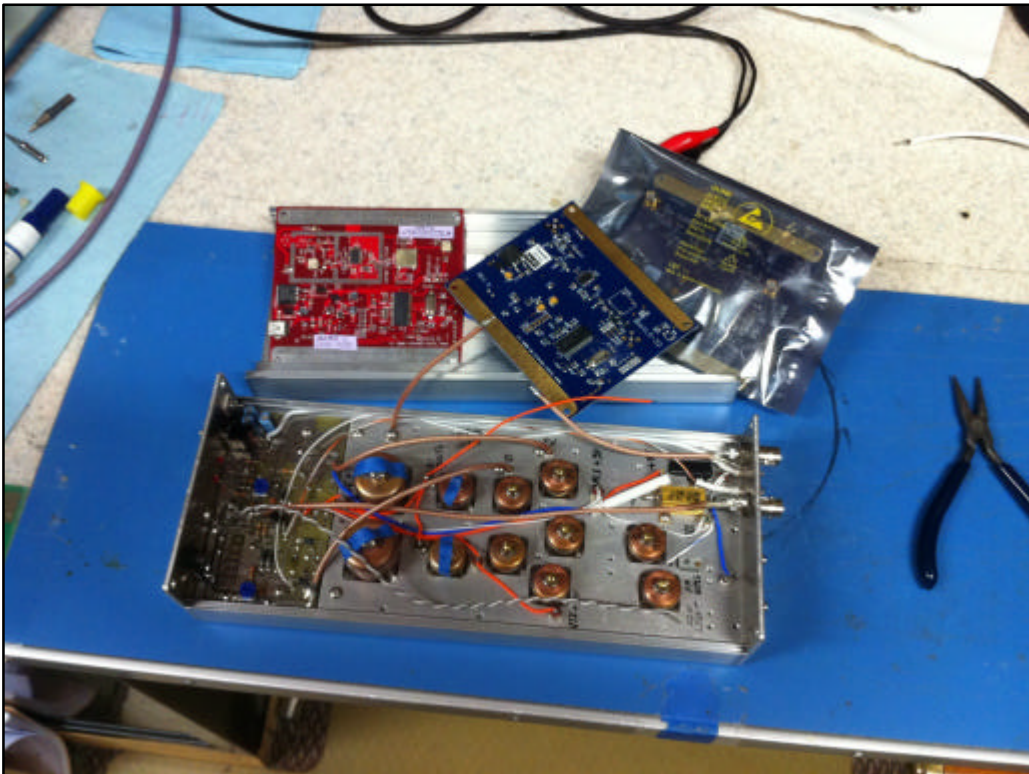
Available selection of LO Boards for evaluation.

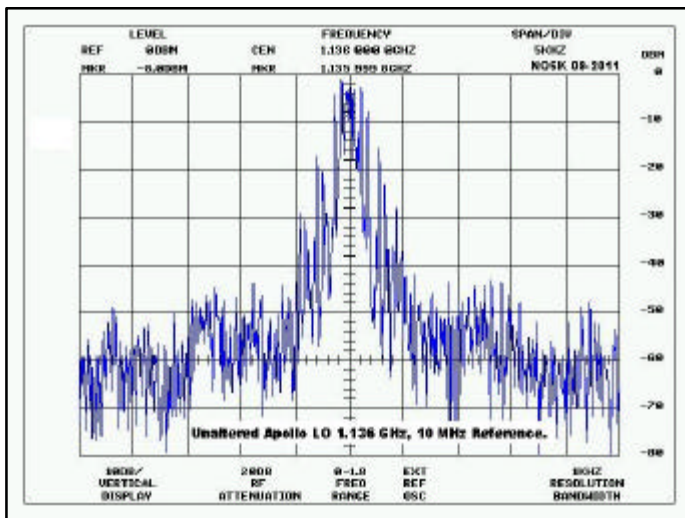
GPS Reference induced Phase Noise, Stock Apollo

Initial start-up using my lab GPS Reference showed excessive low frequency modulation of the 1,136 MHz signal. The original Apollo Board with no added LPF produces clean output with a TCXO. The same excessive LF modulation is present in my original red-board when used with certain External Reference signals..

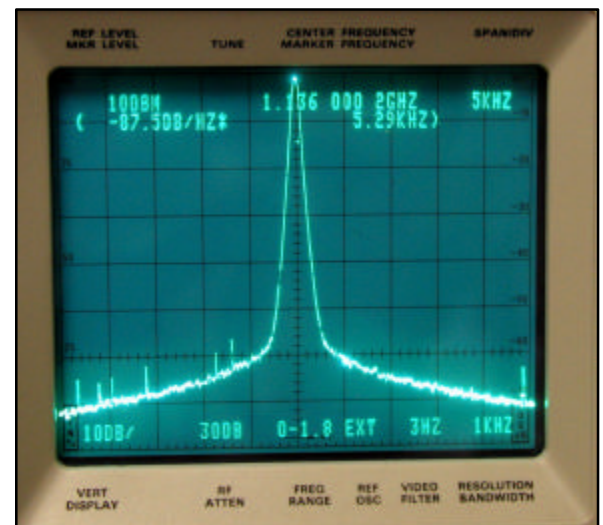
Phase Noise from 0.5PPM TCXO

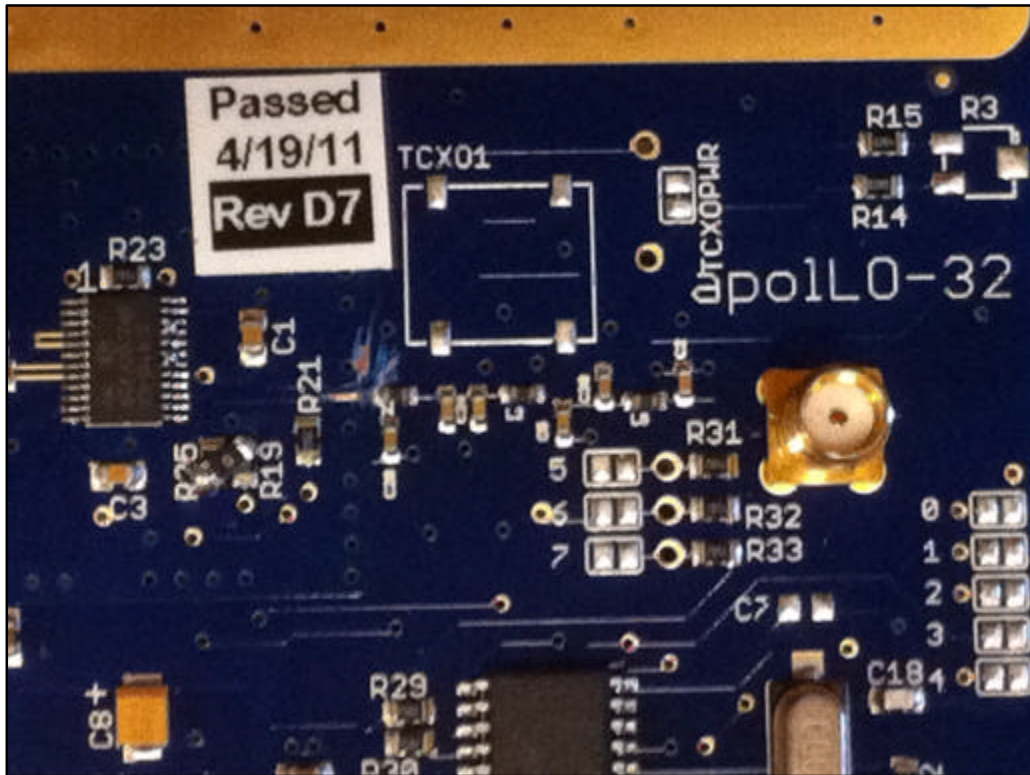
1 nFd blocking capacitor inserted in Reference Input.

Reading the Si 4113 Data sheet shows that there is DC Bias on the Reference Input. Cutting the trace leading to IC1, P\$15 (XIN) and inserting a 1 nFd capacitor reduces the susceptance to low frequency modulation from the reference input. The Decoupling Capacitor reduces the LF noise to some degree even when using a TCXO.

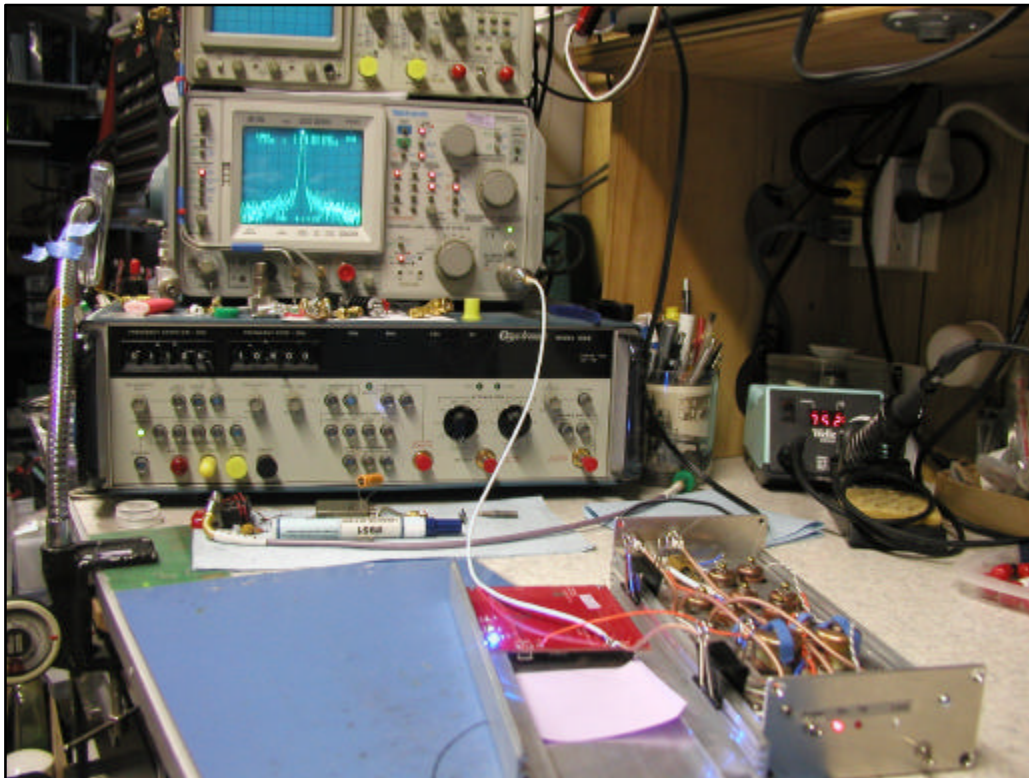
Final configuration with original 2008 Red Board and 0.5 PPM TCXO

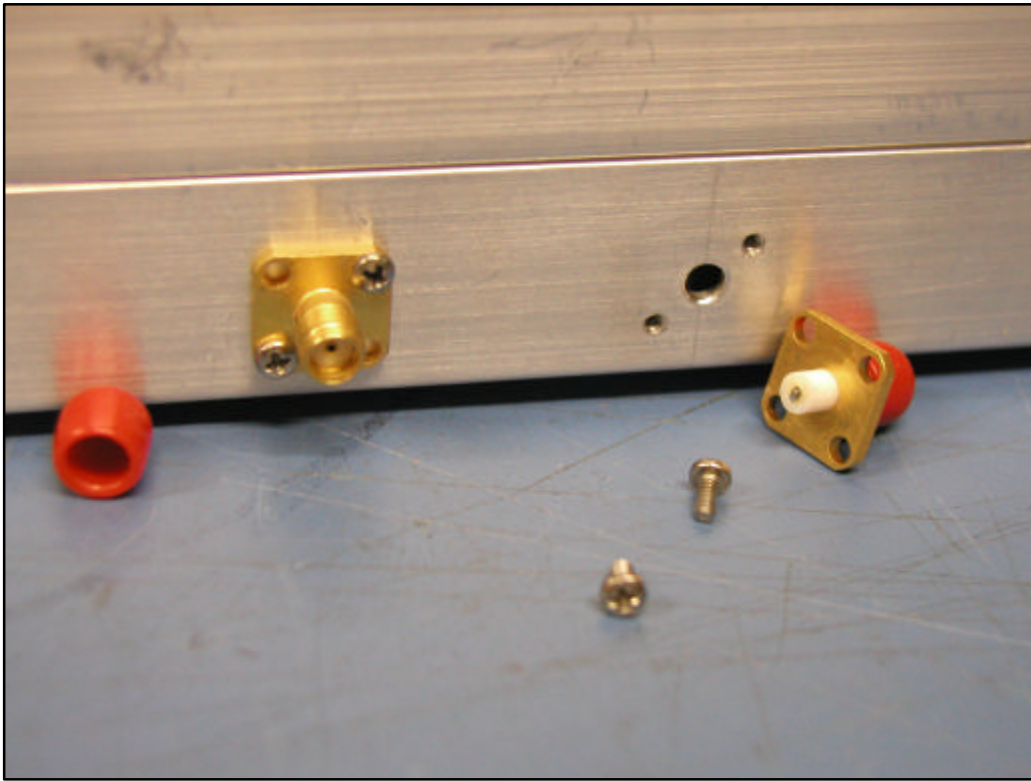
Three sniffer-probes added to accurately check 1,136, 3,48 and 10,244 signals.

Probes do not touch or interfere with the PCB circuitry, simply a calibratable signal pick off point.
Measure twice^{^3} and drill once.
