The Six Centimeter Feed Experiment

Skip MacAulay, VE6BGT

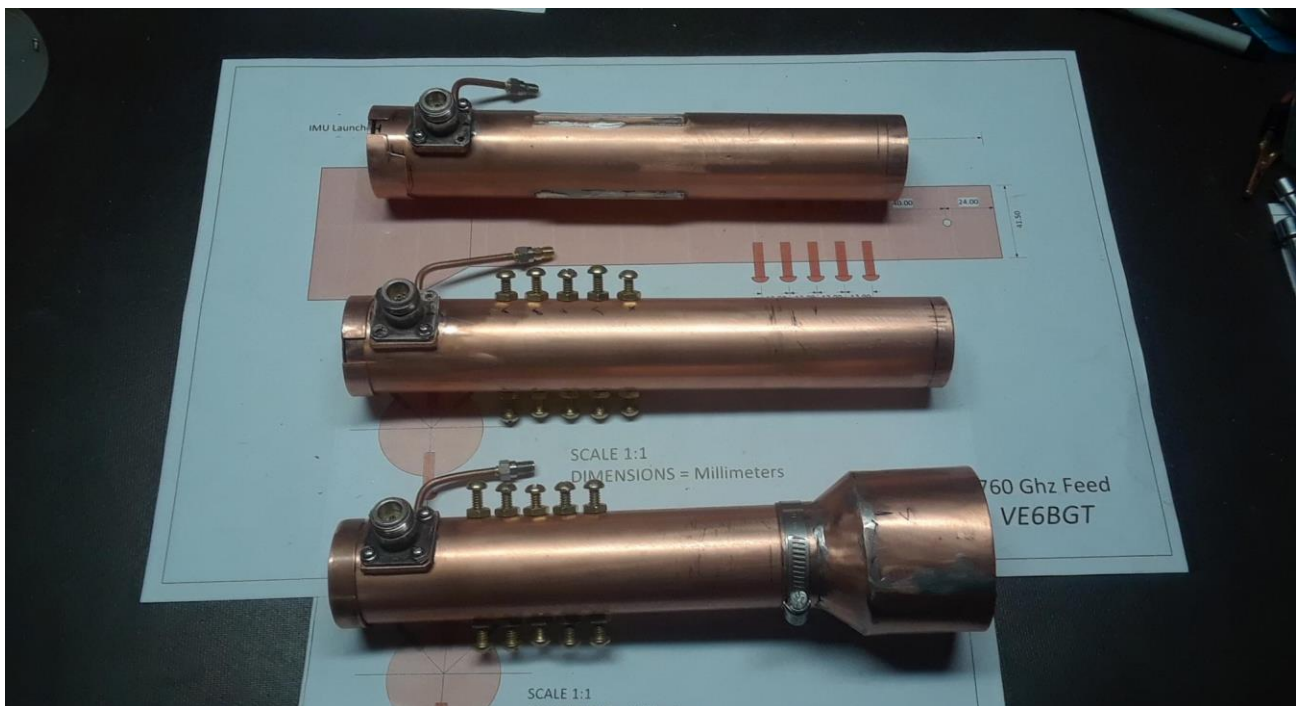
The Three Amigos

I decided to build the squeezed tube one first and tune, then the scaled down bolt polarizer one which made the adjustment bolt placement quite close together. I thought just for experimentation what would happen if I made the copper pipe longer and spaced the polarizer bolts farther apart? So a second one was drawn up and built.

The launcher sections I have used up till now on lower frequencies have always been the scalar ring style. I decided since at this higher frequency and the f/d ratio of my dish being .444, I wanted to try out a W2IMU style of launcher. The same IMU was used at first for all three feeds.

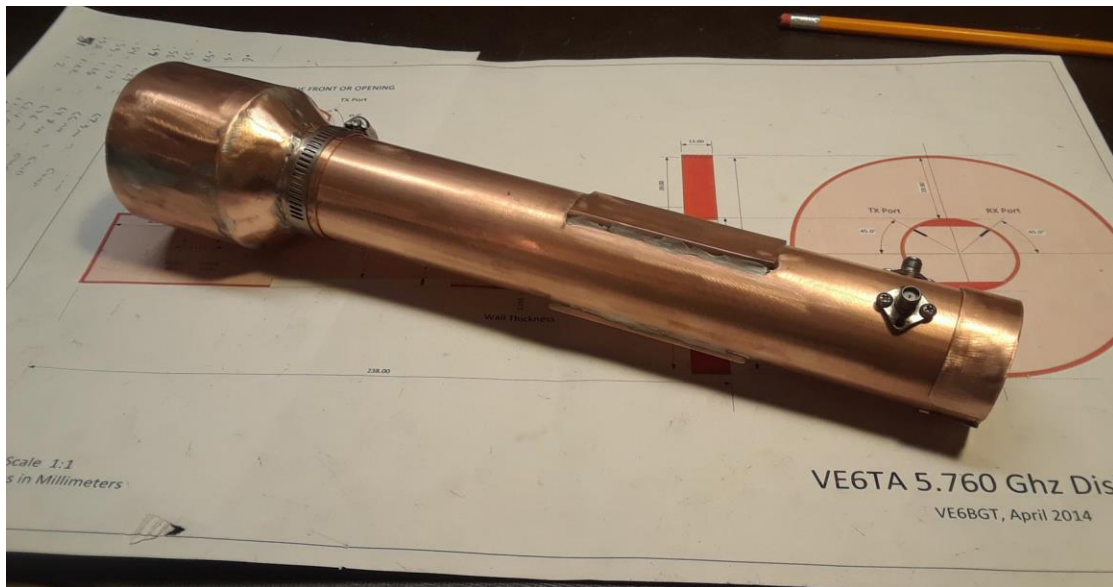
This picture shows the finished squeezed feed with the two plates soldered in and the new IMU launcher section. There is also an adjustable sliding back wall or plate to aid in tuning. I planned on using a SMA connector for the transmit probe only and usually a custom made receive connection made from a piece of .141 semi rigid coax to connect directly to the isolation relay, eliminating one connector for less line loss. I decided I would use the SMA connectors for both at first for the testing.

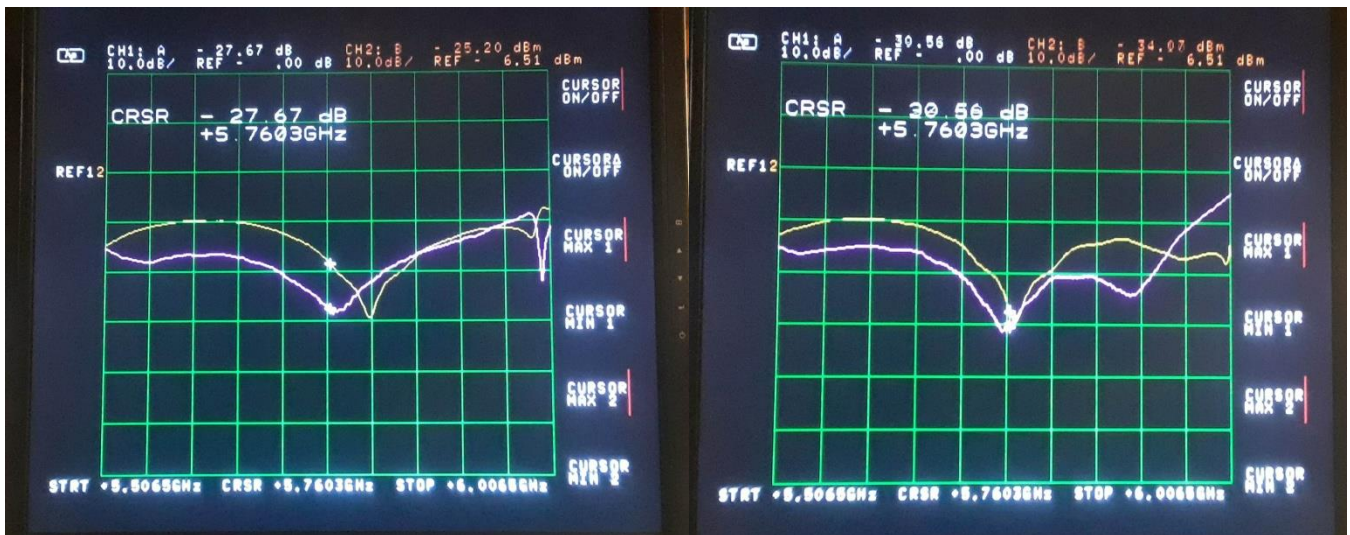
First Sweep: RL = 27 dB, ISO = 19 dB Best Adjustments: RL = 30 dB, ISO = 28 dB

After the new connectors were added the probes were swept and tuned again. The pix on the left are the probes adjusted and the back plate tight up against the body, the IMU launcher is completely off. The right pix is the best of all adjustments, the back plate moved out 1 mm, the IMU installed and slid out 4.5 mm. One thing I really noticed was the accuracy of construction the IMU launcher needed to be.

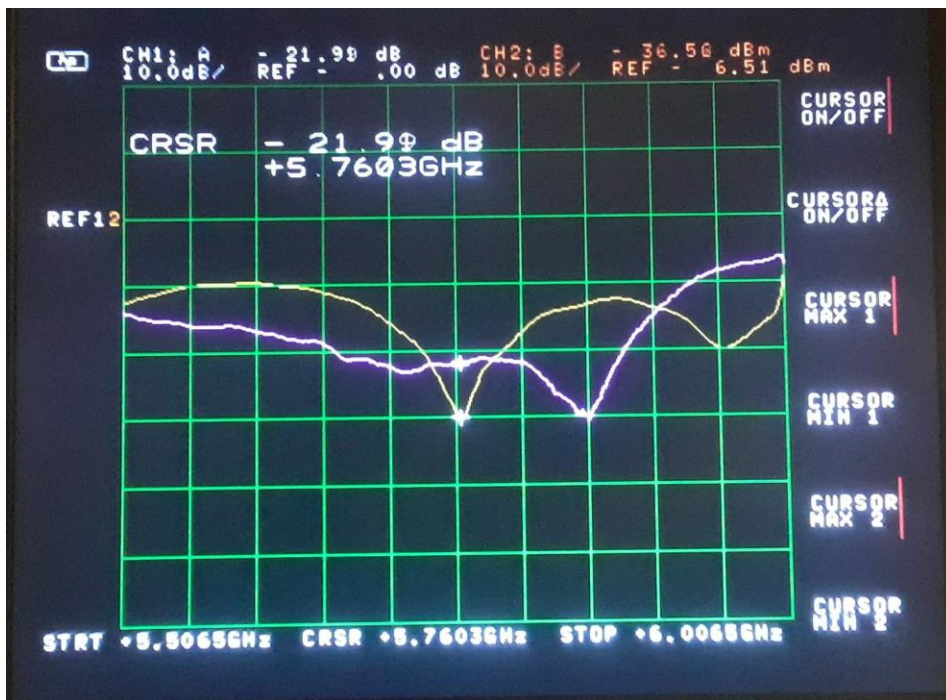
Twisting the IMU launcher section mounted on the end of the feed tube really shifted the RL dip of the TX probe off frequency. This showed me that the IMU section wasn't built concentric or true accurately enough.

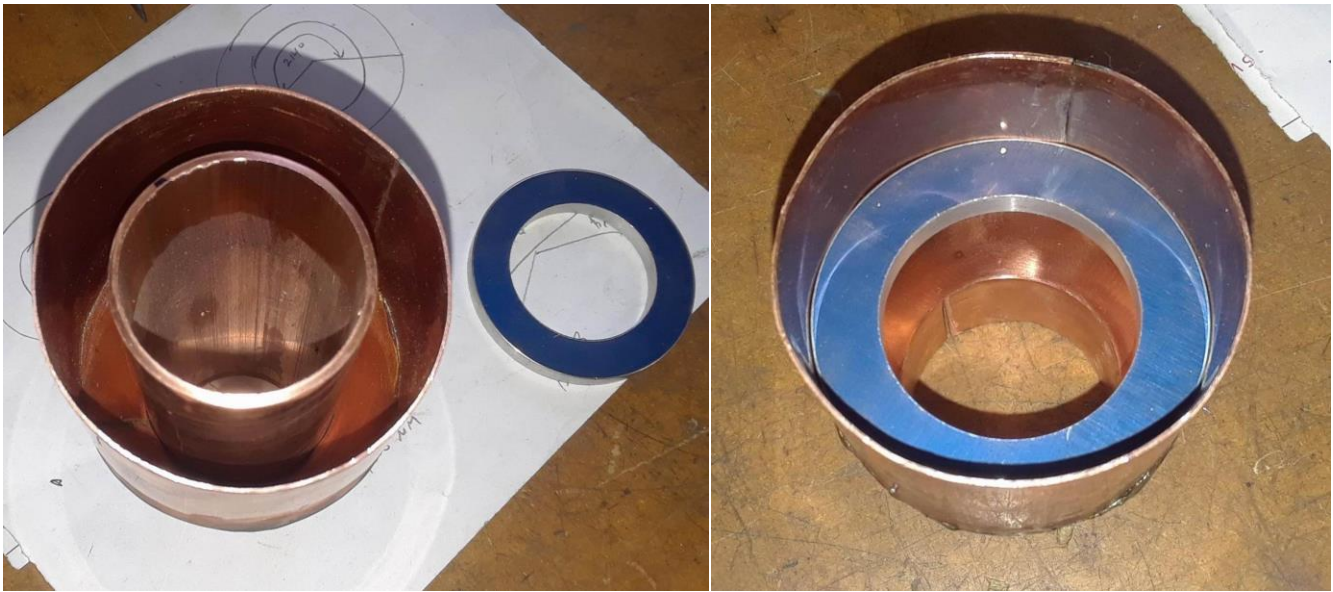
The New IMU Launcher Construction

With a special ring lathed from aluminum and placed inside the launcher section, it held the funnel centered and clamped on the main copper pipe waveguide. It was then soldered being held in place making it concentric or true.

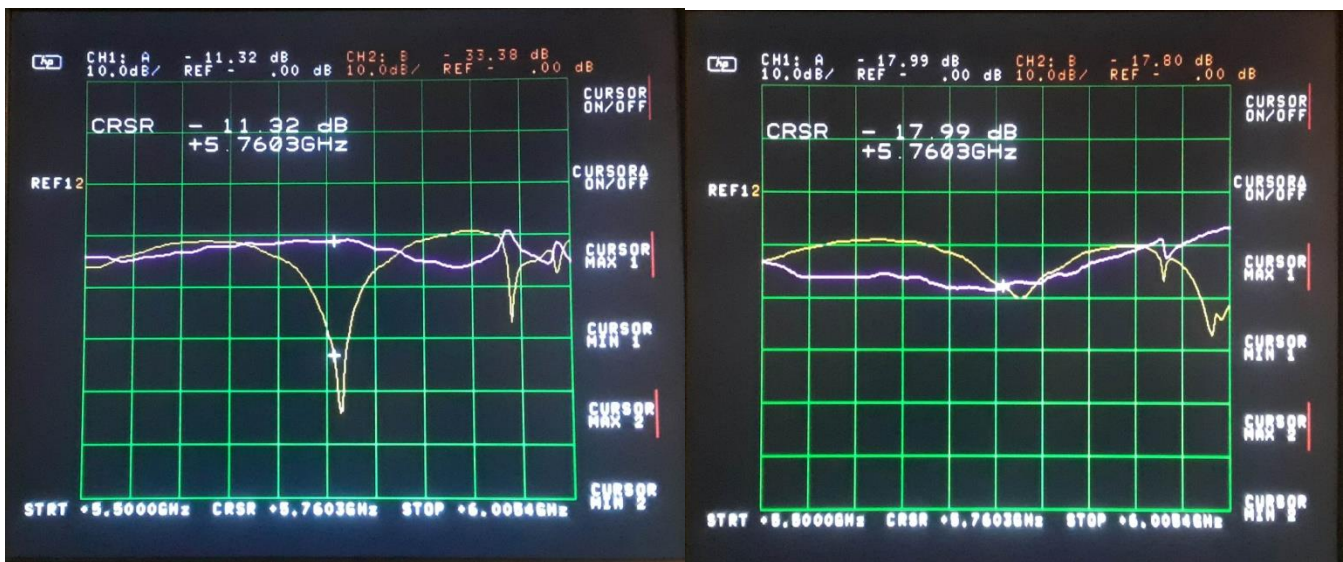
Either the Return Loss Would Be Good, or The Isolation, Never Together

Like before with the shorter feed that tuned well with the CP bolt adjustments, I set out to tune this longer one to improve the Isolation and Return Loss. It was not to be; no matter what I did or tried I could not get both situations to improve together. It was a battle and I spent a long time on it trying to see what would be the sweet spot. The only difference again was that I had a SMA connector on the TX probe, and the spacing between the CP bolts is wider compared to the shorter feed.

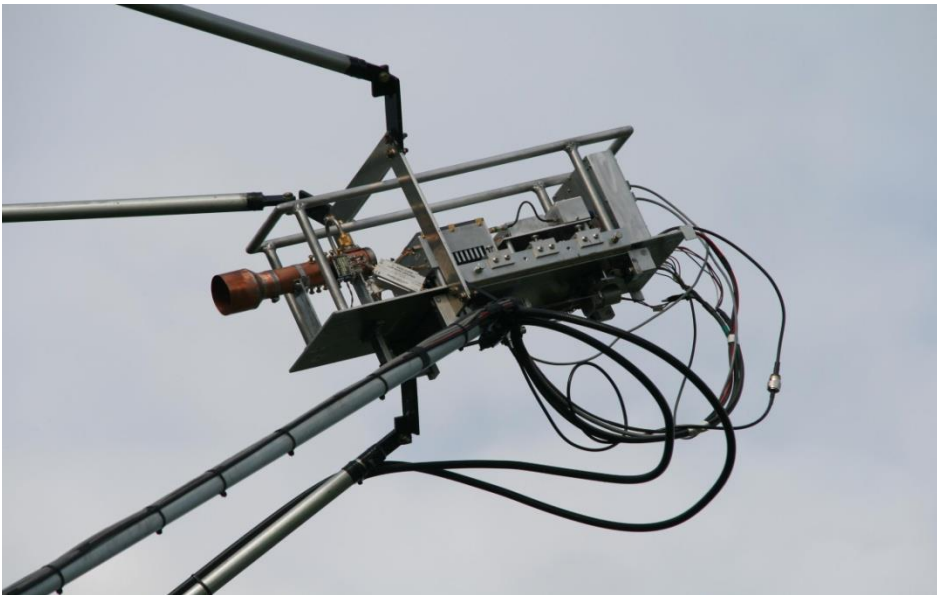
The new 6 CM feed assy. mounted on the 21 foot dish for final testing. Underneath is a feed position actuator to slide the assembly in and out for peaking on solar noise etc.

This actuator has a position sensor that is connected to the PIC circuit and position data is sent back to the shack for monitoring.

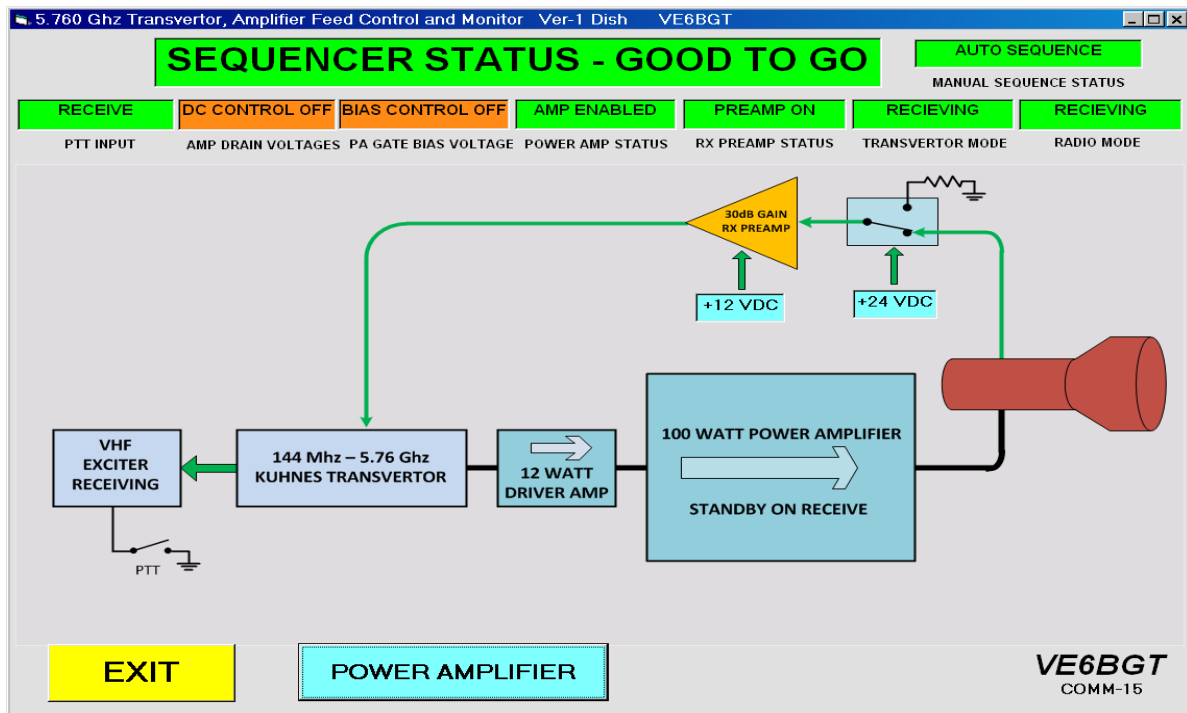
The 6 CM Monitoring and Control Screens

A screen shot of the 6 CM system status in receive mode.

The 100 watt amplifier and various voltage point status monitoring in receive mode.

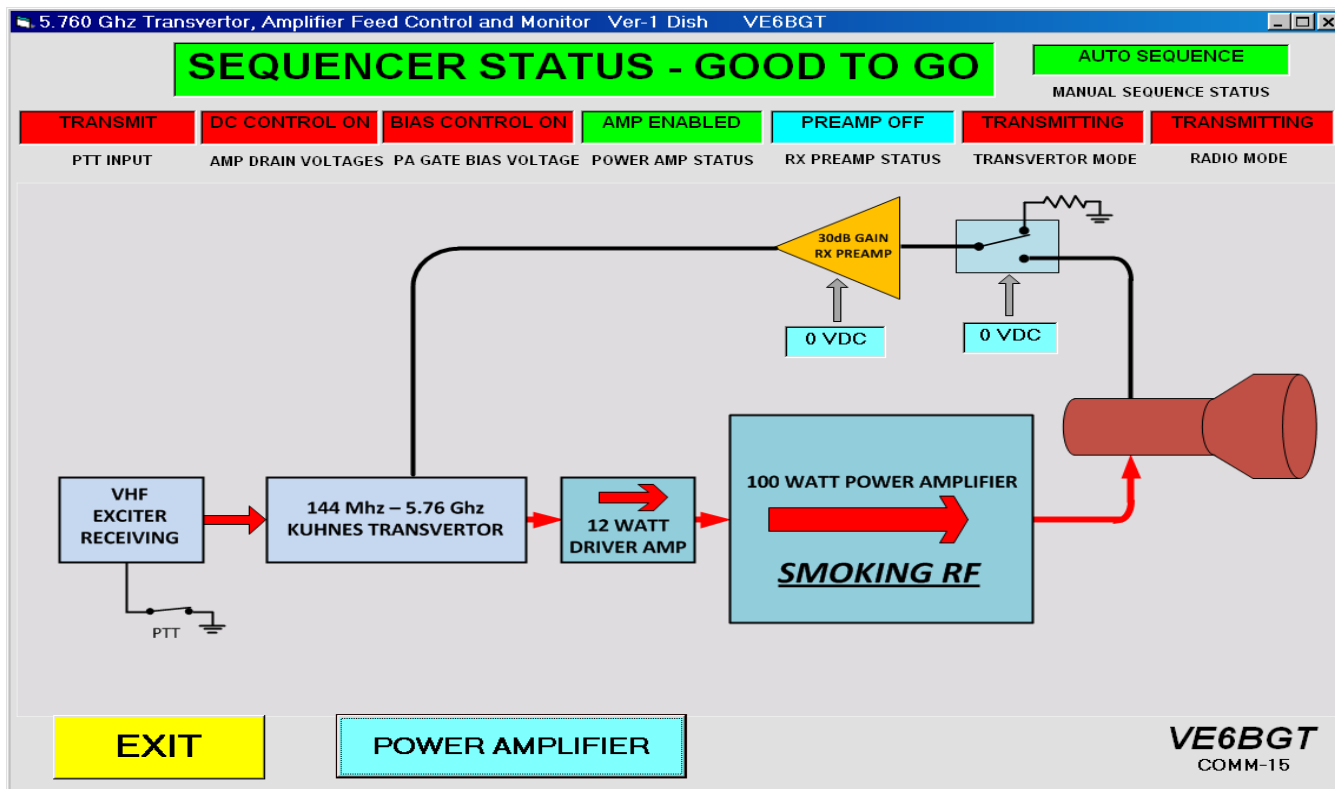
6 CM System Status in Transmit Mode.

Amplifier Circuit and Voltage Points in Transmit Mode, Keyed Only.

One of the Numerous Fault Warnings, Missing Amp Voltage.
